Clinical Bulletin J. LAHA, Vol. 2019, No. 1; p. CB09.

Ceramic Bridge Debonding

Dr. Dmitri Malev

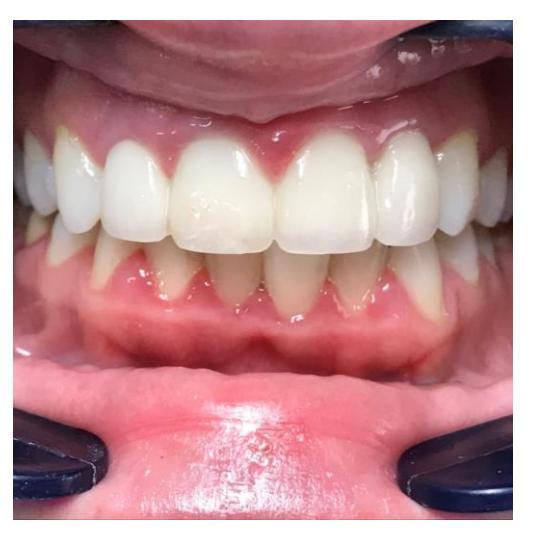
Before

Starting on the facial gingival margin surface with low energy (200 mJ), Er:YAG laser (LightWalker) with a H02 handpiece was used with a slow painting motion, moving from bottom to top, back and forth on the mesial and distal side. On the facial, palatal, mesial and distal surfaces energy was increased up to 280 mJ. The crowns were successfully removed after several downward pulls with a curette.

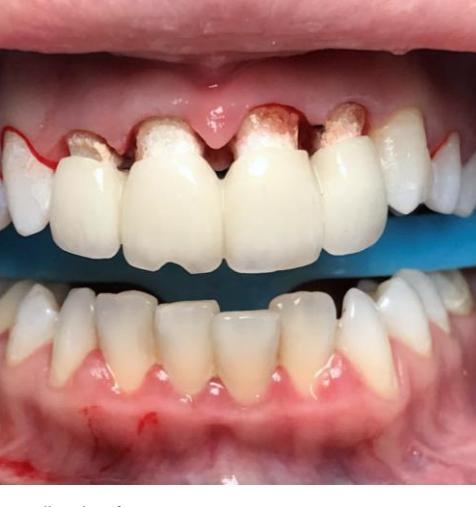
Immediately after

No complications were observed during or after the treatment. The clinician should extend care when using mechanical means of removing restorations after the laser is used. Ideally, a small overhang in one area will help provide a "catch" of the crown edge whereby the clinician may remove the loosened restoration via a controlled downward pull.
